# REVIVING AGING INFRASTRUCTURE

Sustainable approaches to repairing and protecting  
sewer and storm systems

# AGING INFRASTRUCTURE HULL, MA MANHOLE REHABILITATION

AUTHOR: RAY BAHR, P.E.

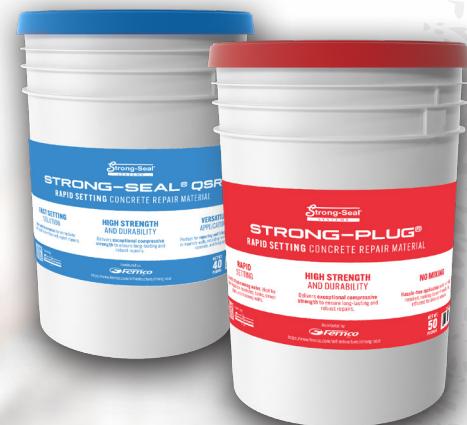
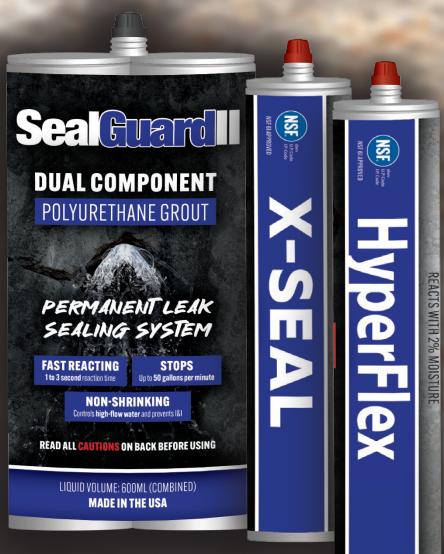
## RAPID WATER CONTROL

Strong-Seal® Manhole solutions deliver quick, high-strength repairs to stop water and infiltration in minimal time.
